Gompu: A Neglected and Remote Sasanian Dam

Mohammad Jafar Malekzadeh

Architectural and Engineering Characteristics of Gompu

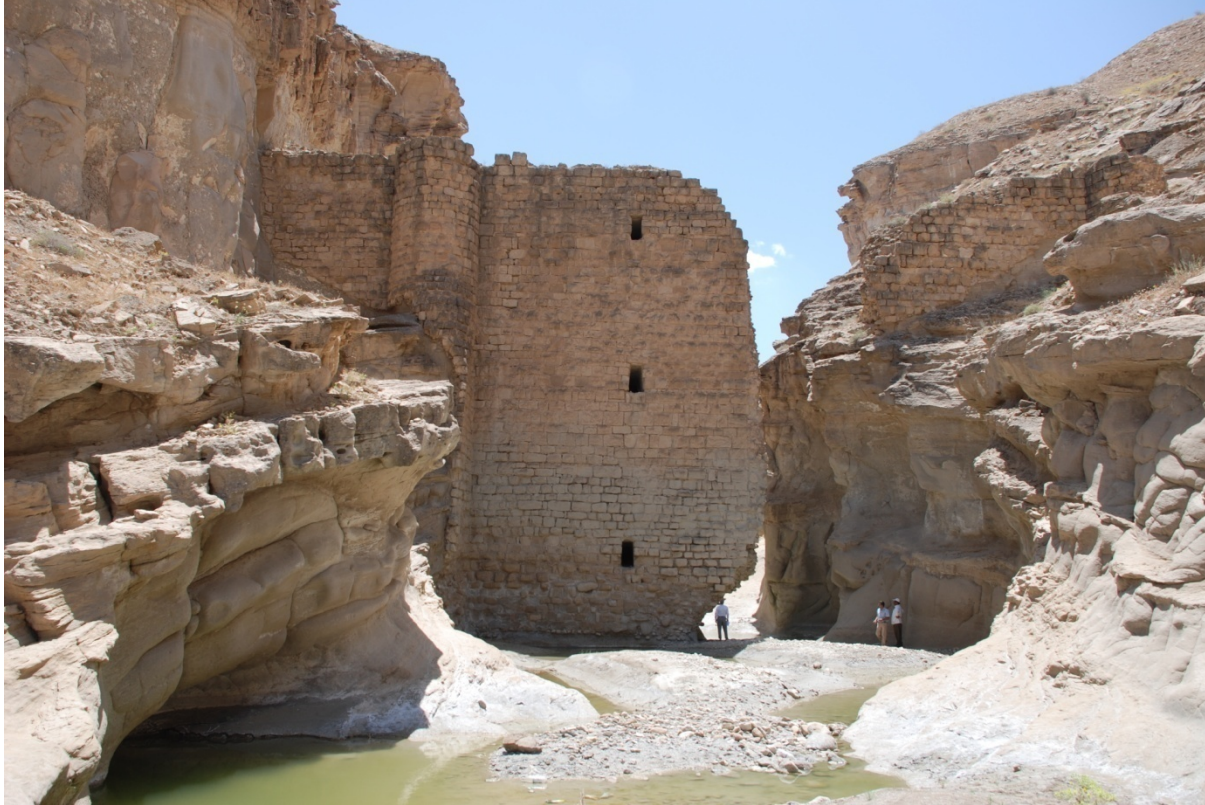
Photo 1: The downstream view of Gompu. The western section of the dam has collapsed, and its debris has been washed away by flood water. The bed, body and abutments of the dam are extremely vulnerable to erosion. The tall eastern pier or half cylinder and the short western one are visible in the photo.

The destructed part of Gompu is not insignificant or small. It is about 300 cubic m. and there had been an estimate of 10,000 pieces of crushed stone and face stone used in the construction of this section of the dam. Author believes that the destruction had taken place soon after the construction was completed. The first supporting reason is that if water had accumulated behind the dam for several years, there would still be traces of water flow marks on the downstream of the dam and beneath the orifices, while there is no sign of any water flow marks or water erosion on the wall of the dam. The second sign of early destruction is that the depth of erosion in the destructed section of the stone bed of Gompu is more than one meter. It must be noted that this area has a very low level of precipitation and that erosion of the bed of the dam takes a very long time and must be the result of many centuries of water erosion.

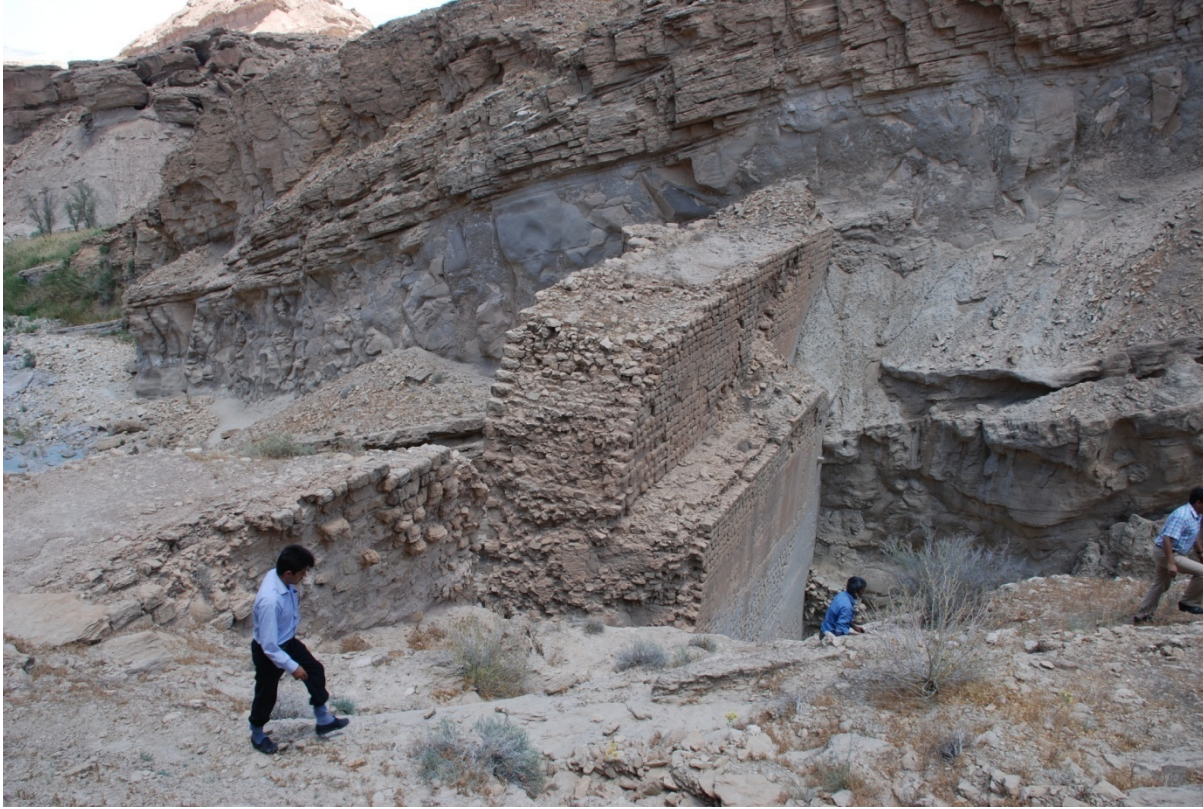
Photo 2: This photo depicts how the thickness of the body of the dam has abruptly decreased from 6 m. to 4 m. Here we can see also that the upstream face of the dam has been plastered with a 2 cm. thick *saruj* mortar.

The third and final point is that the thickness of the wall of the dam suddenly decreases from 6 m. to 4 m. at the height of 9 m. At present, the total height of the dam is 15 m. The stones used in the face are dressed and square shaped. The dressed stones of each course both in the

upstream and downstream faces of the dam, are of equal height but non-equivalent lengths. The height of each course varies from 30 to 50 cm. The upstream and downstream faces of the dam are of regular coursed rectangular stones which, were quarried from the vicinities. Weathering has altered the surfaces of the facing stones. The designer had had the upper face of the dam covered with 2 cm. of finishing saruj mortar, knowing that water penetration could be of grave danger.

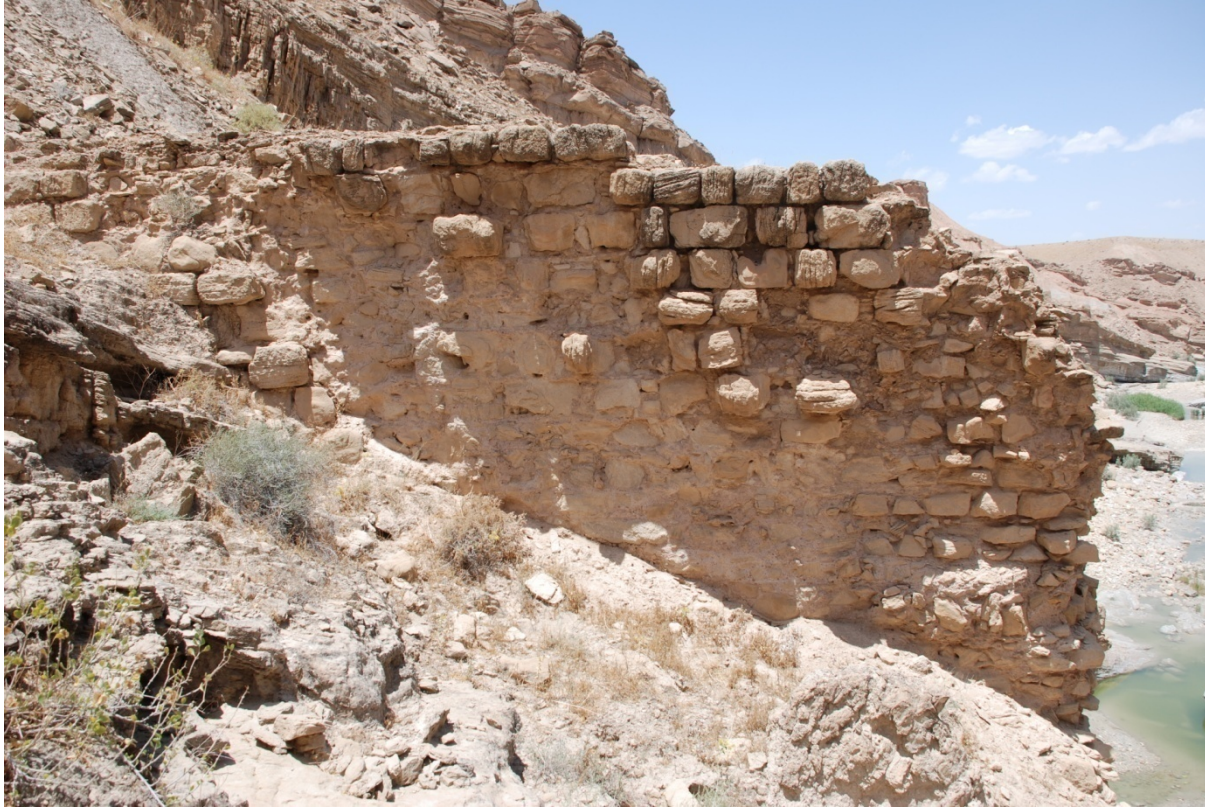
Photo 3: The upstream face stones of the left upper part of the dam has gradually been worn off and powdered into dust. The weathering and gradual disintegration of the face stones has happened due to the weak quality of the stone not water or wind erosion.

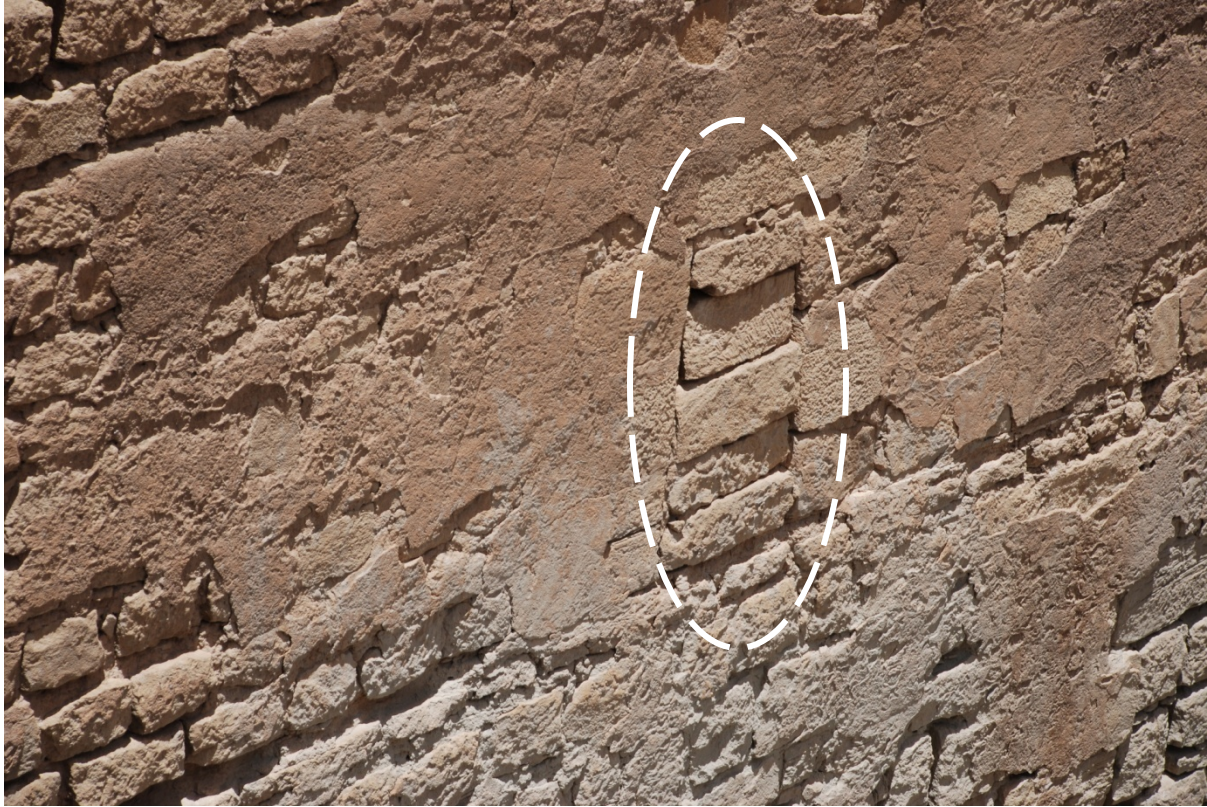
Photo 4: The upstream view of the middle one of the triple orifices. Here dry masonry has been used and it has not been covered with plaster mortar.

Although very unique, Gompu is not very complex in architecture and structure. It basically connects the walls on the two sides of the valley. Nevertheless, there are three interesting points in the architecture and engineering of the dam. The first is that there are three rectangular orifices of the same size all in one vertical line in the downstream face of the dam. In the upstream face of the dam the orifices are covered with dry masonry in order to allow water to seep out gradually from the upstream of the dam. The use of dry masonry in the orifices is to enhance the ease of removal in case of need.

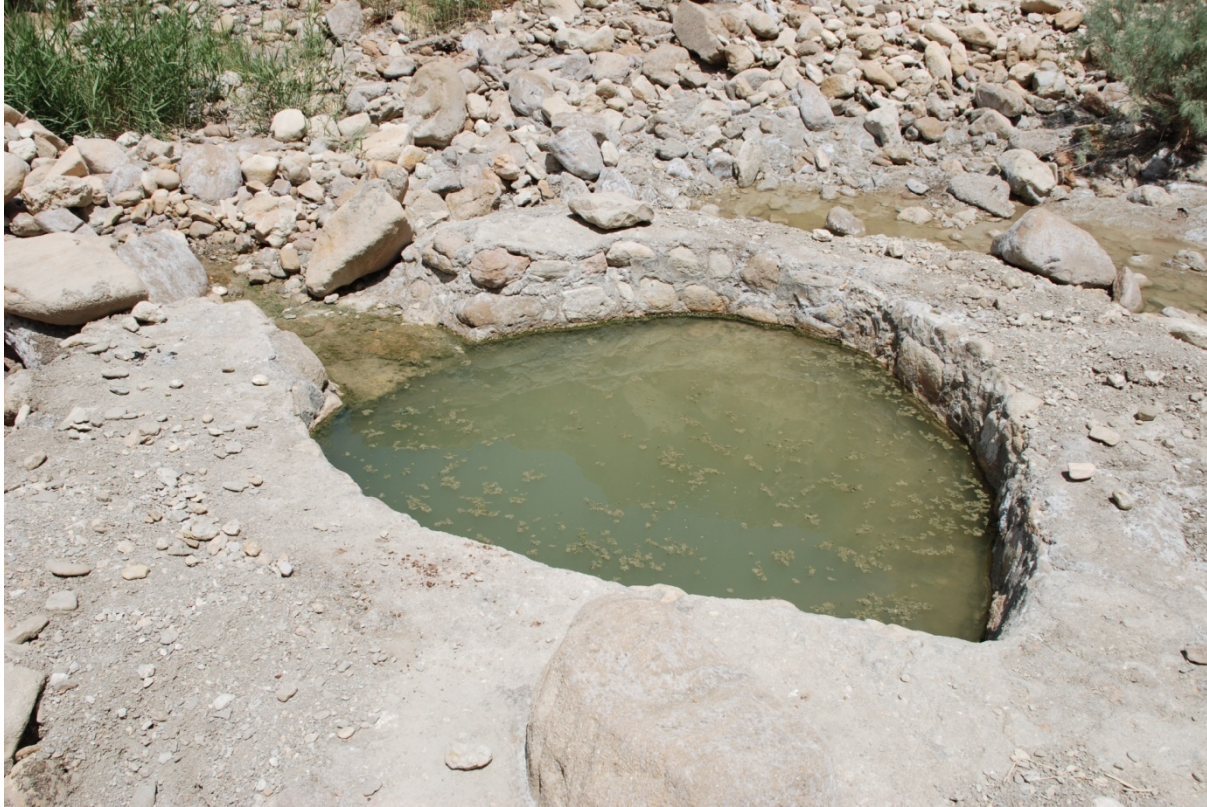
Photo 5: The holy stone pool is filled with mainly surface water and a little underground water seepage. During warm seasons when there is little water influent and much evaporation, water does not overflow from the pool.

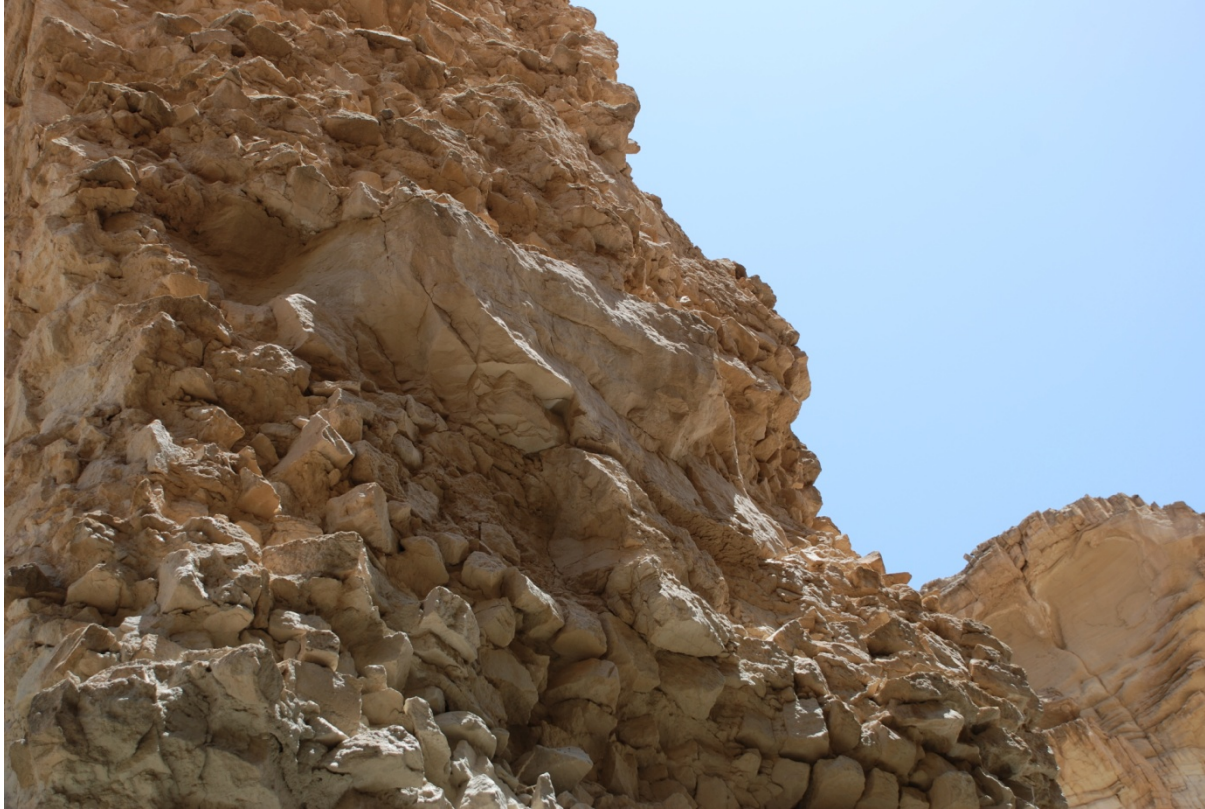
Photo 6: How has this huge and extremely heavy piece of rock been placed in the body of the dam? The truth is that this enormous piece of rock had been part of a much bigger piece which had protruded from the left abutment. The builders of the dam used this overhanging piece of rock to increase the interlocking of the dam to the mountain and to compensate for a large amount of stonework. However, they were not aware that this is a grave engineering mistake, because no matter how much precision was put into work, they would have never been able to fully fill up the empty space beneath the irregular surface of the overhanging rock. The weight of the stonework on the cantilever rock plus the heavy weight of the overhanging rock itself, the empty space beneath the rock added to the low strength of the rock worked together and resulted in the protruding rock to suddenly break into two or three pieces. It is almost for certain that the broken pieces had fallen a few centimeters, and had had a great impact force on the masonry beneath it, a force so strong that was enough to bring about the disintegration and collapse of left part of the dam.
